PRELIMINARY ASSESSMENT

SUBJECT: Foseco, Inc., Chicago, Illinois

ILD051067866/F05-9104-017/FIL0458PA

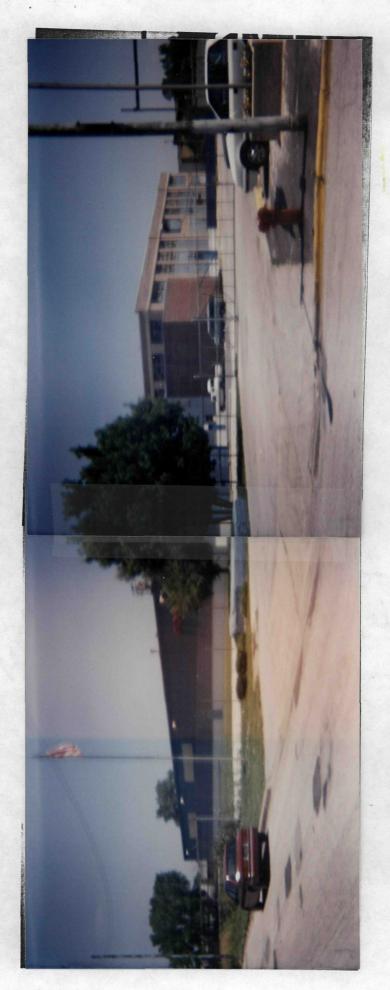
SAMPLE ID (if applicable): N/A
SABLE TAKEN From LAWY ley Ave. PHOTOGRAPHED BY: Grey SUNGSTON DATE: 6/18/91 TIME: 13:00 DIRECTION OF PHOTOGRAPH: NE DESCRIPTION: PANOTAMA OF From tor Fosaco MAIN Drive-way with MAIN GATA WEATHER CONDITIONS: SUMMY 850

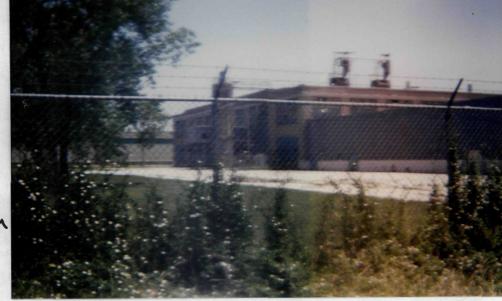
DESCRIPTION: NW CUINN OF plant

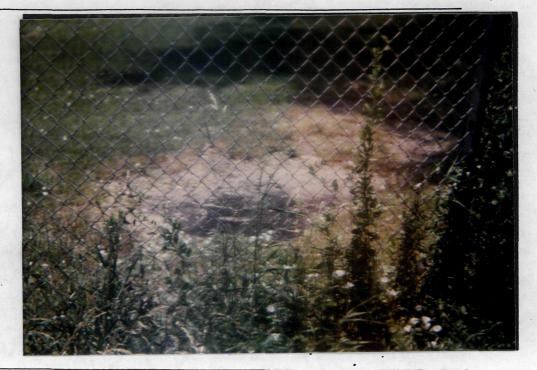
small area of soil in the northwest corner of the site that appeared to be stained.

STAINED Soils located on the north size
